Cause analysis and treatment measures of oil leakage fault of high pressure piston pump skeleton oil SEAL

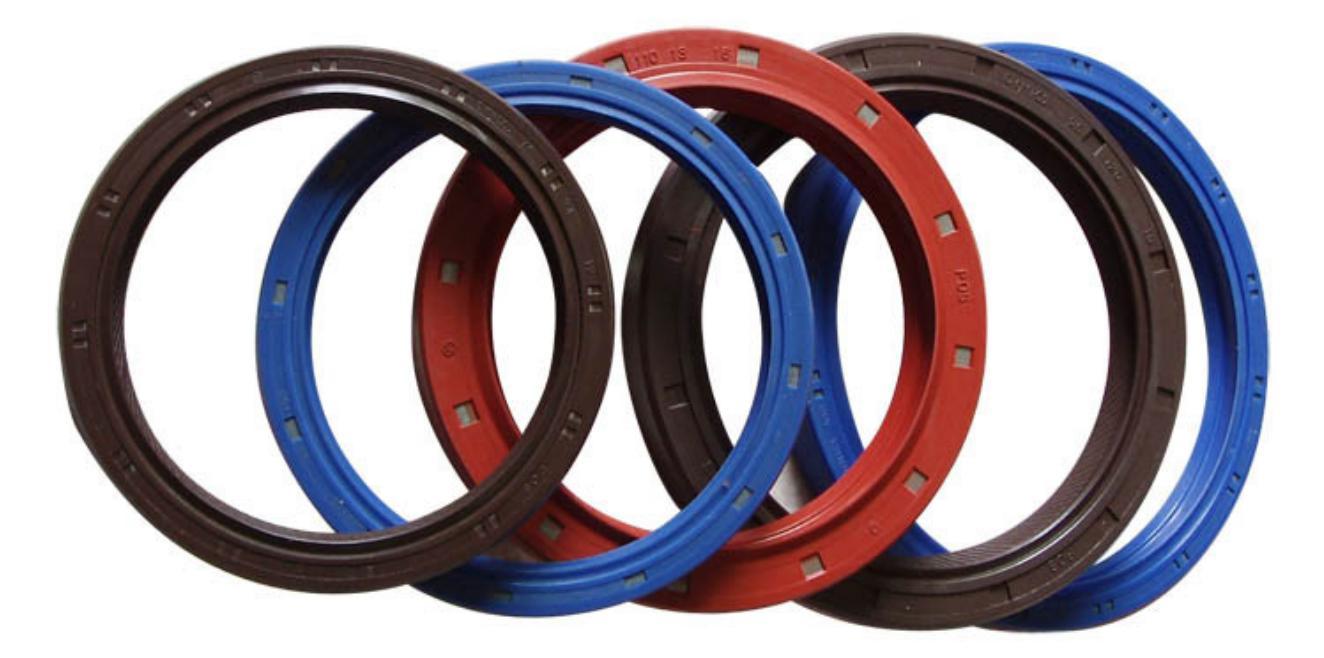
Piston pump crankcase In the use of splash oil lubrication, in the crankshaft and cross head connecting rod and box outside the connection between the installation of skeleton oil seal, to prevent oil leakage. The skeleton oil seal is composed of oil sealing body, strengthening skeleton and self-tightening helical spring. The inner diameter of the rubber lip of the oil seal body is smaller than the outer diameter of the shaft neck and the connecting rod, and the excess fit is used in the installation. Piston pump In the course of operation, often there will be oil leakage phenomenon, sometimes after the replacement of a short period of time there is oil leakage. This not only causes the pump to run the time oil consumption increase, at the same time the oil position drops will also cause the crankshaft bearing and the cross head cylinder lubrication condition to become worse, is prone to the crankshaft tile or the cross head pull cylinder accident.
